# ***The Occidental Chemical Center***

***Niagara Falls, New York, 1980, Cannon Design Inc.***

## ***Design Intentions:***

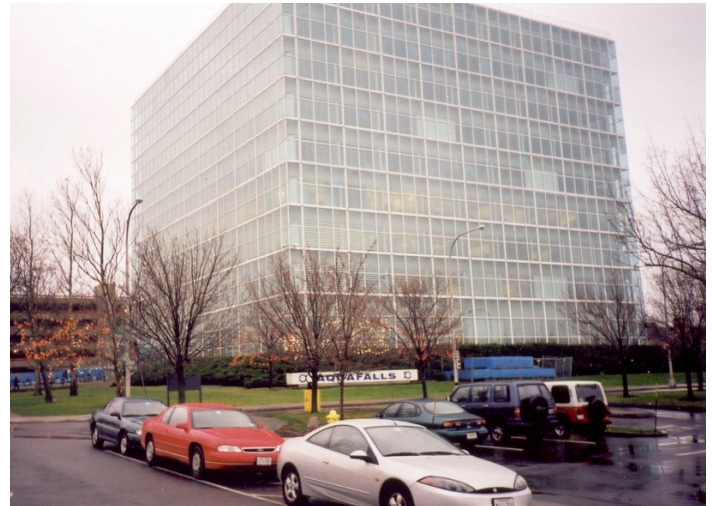
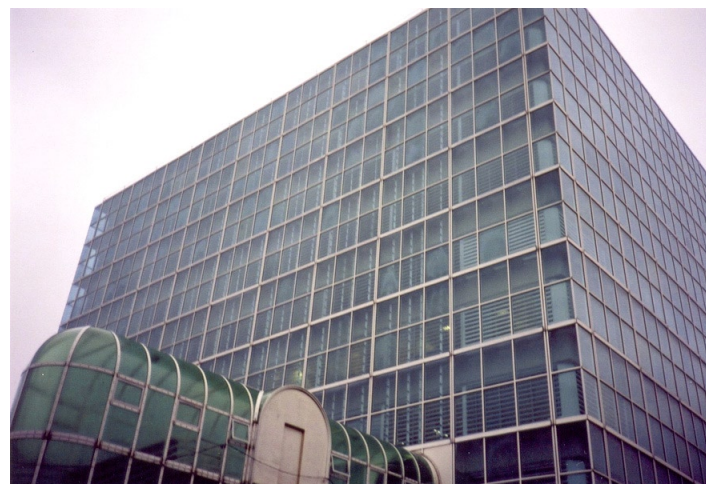
*The Hooker Building West facade from Niagara Gorge parking lot and detail of the Southeast corner with pedestrian bridge that formerly connected to the parkade.*

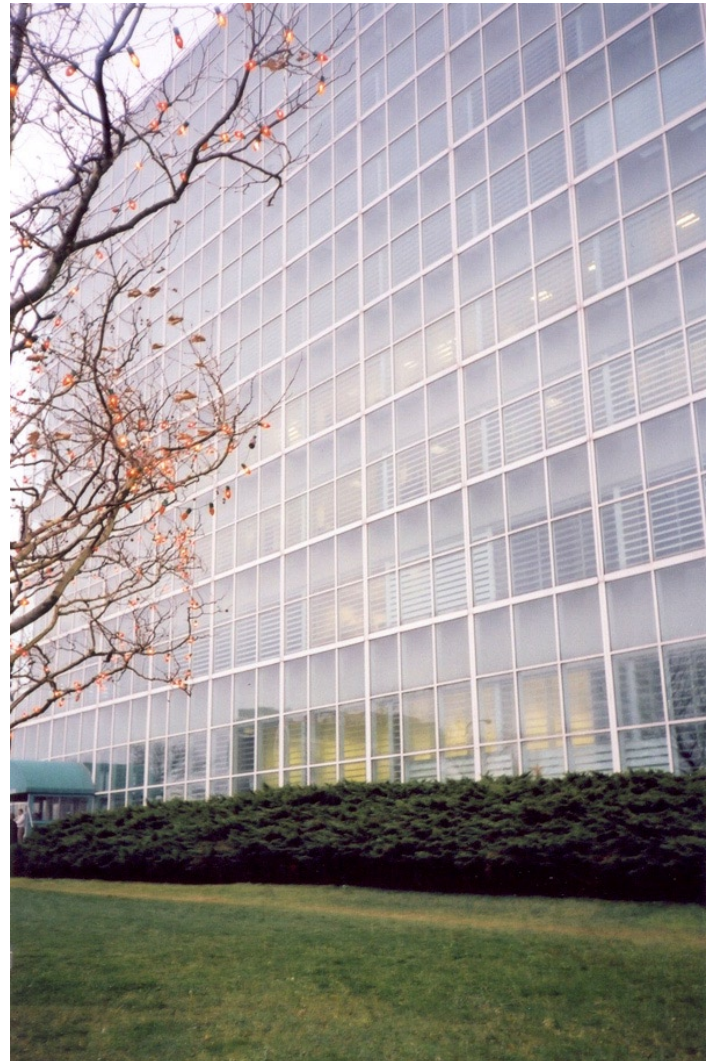
*Above: the current North Facade. Below: floor plans showing the original entrance cut into the East facade; the only place in the building where the otherwise uniform facade is interrupted.*

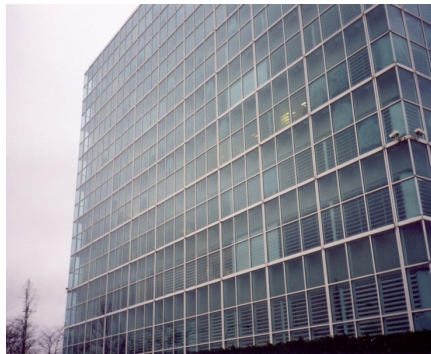
The Hooker Building Southern facade is pictured here along with the thermal zoning design schematic showing both areas with daylighting and the differing HVAC zones, along with both vertical and horizontal sections through the buffer facade.

The building envelope is comprised of two layers of green-tinted insulating glass that allow for 80% solar penetration as the exterior skin, a 1200mm air space containing hollow metal, air-foil shaped, white louvers - spanning fifteen feet and vertically spaced eight inches a part - with service grilles (originally covered with beige carpeting to give the appearance that the floor continued from within the offices through to the exterior glass), and one layer of clear glass as the interior skin. As a means of being economical, the architects made sure that all the components of the façade -

save the control and monitoring equipment - were “off the shelf.” The louvers in the air cavity are controlled by an “intelligent” light sensor system that responds according to weather, time of day and season. The sensors are placed in pairs to discount mullion shadows and a delay response cancels the effect of passing clouds. The façade is separated into four different “zones” according to the North, South, East and West exposures so that each of the four walls may respond according to the amount of daylight being admitted according to the particular time of day. The louvers are capable of fully closing as means of providing additional “insulation” during the winter months.

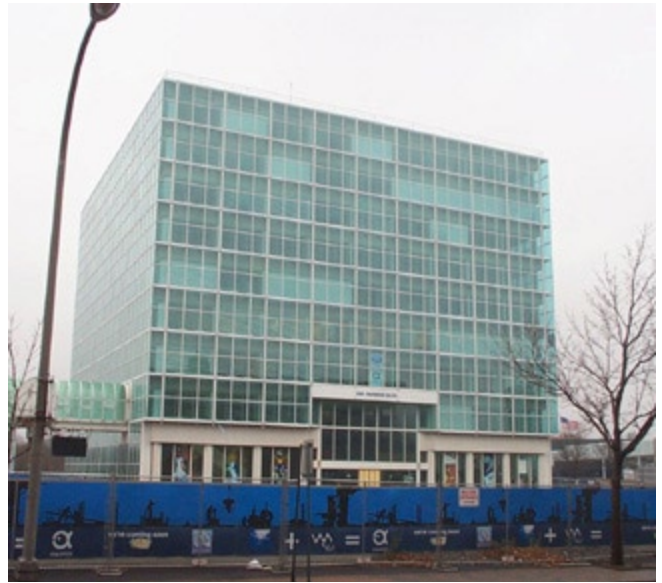
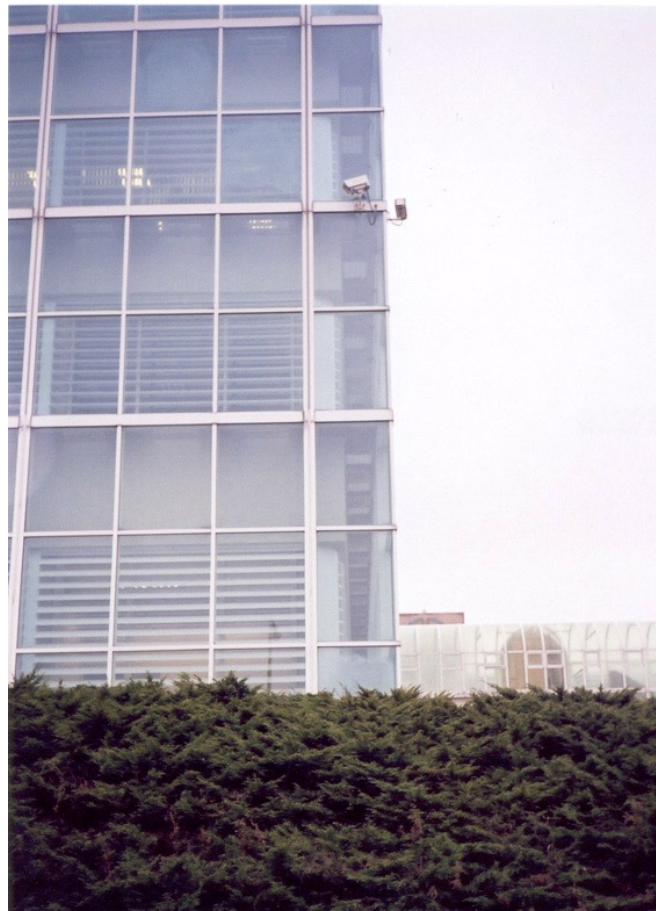
*The original East entrance now overlooks the excavation for the aquarium, as a corner detail reveals a glimpse into the currently inactive wall cavity.*

According to the security personnel the louvers ceased to function four years ago, and haven't been serviced since. Because of this they are stuck in a horizontal position and only negate 50% of the incoming solar radiation on the South side of the building and even less on the East and West façades. Tenants have since taken the initiative and installed vertical blinds on the inside of the office space in an attempt to have some solar control. Because of the current disrepair and neglect of the building in its interim state, the current tenants of the building constantly complain of being either too hot or too cold. There

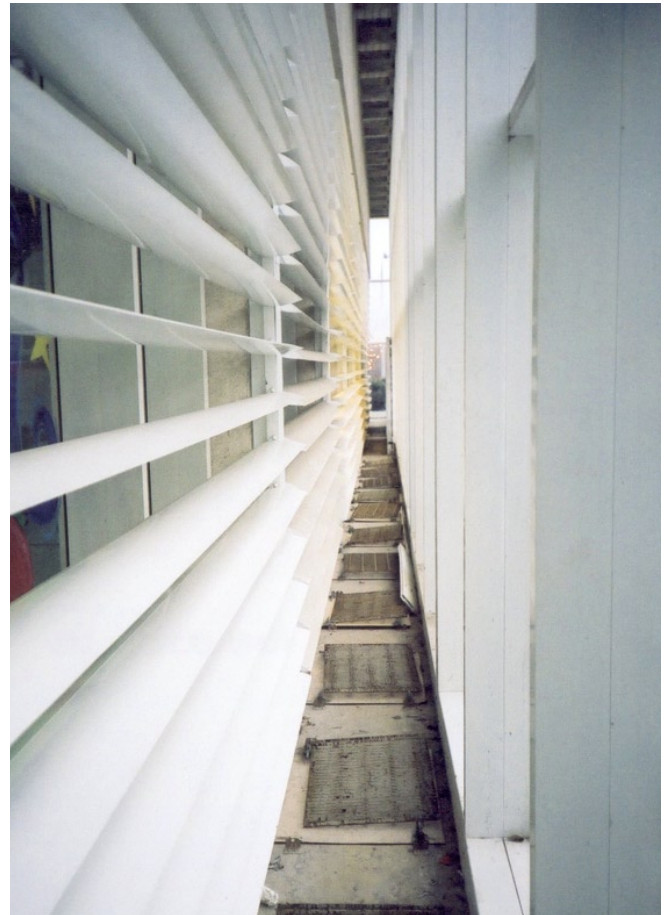
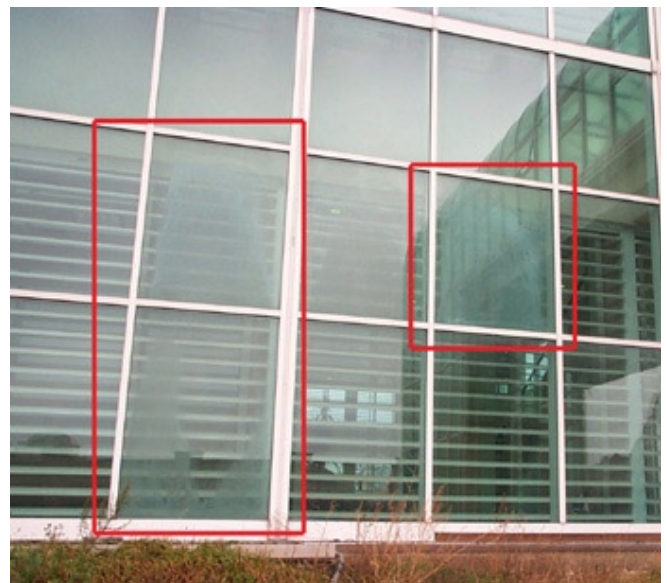
*Photos of the interior of the wall cavity and clouding of the exterior skin. Detail photo of skin clouding taken by Terri Meyer-Boake.*

has also been significant clouding formed on the inside of the exterior glass, resulting in a blemished façade.
